Appendix A:

Analysis of the Former Black River Canal

Lyons Falls Brownfield Opportunity Area

Step 3 Implementation Strategy

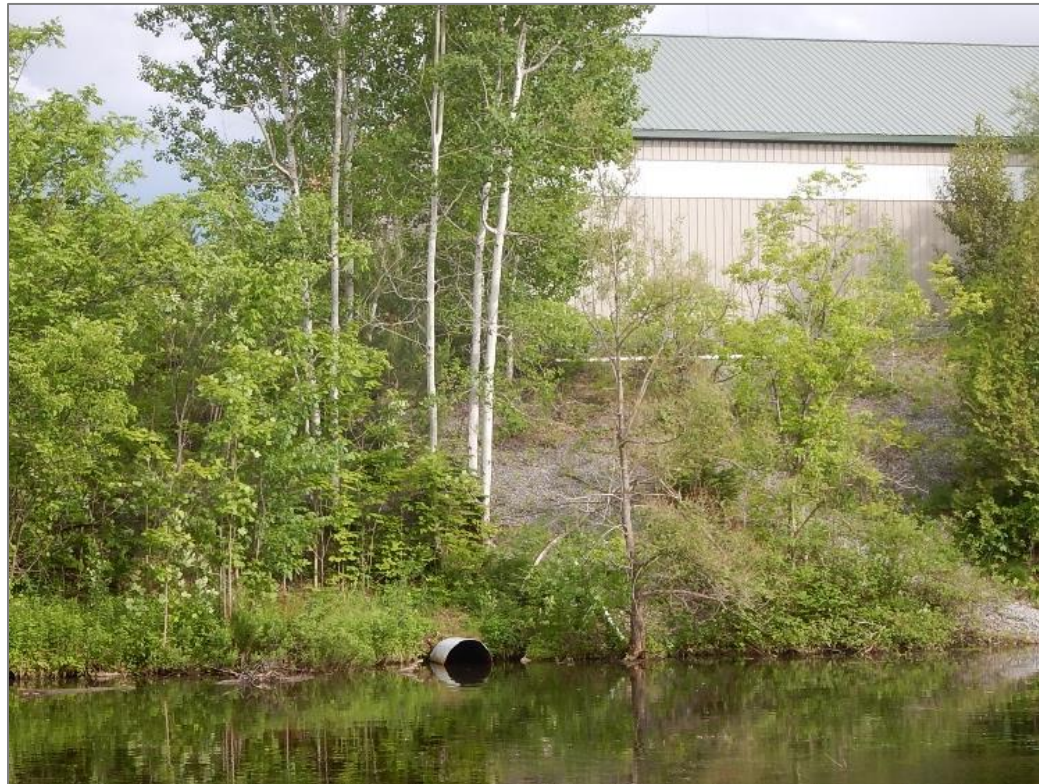
Figure 4 Storm Sewer Outlet into the Turning Basin

The outlet can be seen from the north side of the Turning Basin (). The outlet is visible and appears to be in satisfactory condition. The storm sewer outlet appeared to be nearly half submerged. Although there was audible flowing water at MH-2, there was no visible evidence of flow into the Turning Basin from the outlet.

The storm sewer outlet as described above is a 33" diameter CMP, which is approximately halfway submerged in the Turning Basin. The outlet is pictured in Figure 4.

- Option A includes deflecting the storm sewer inflow into the Turning Basin to prevent short-circuiting of flow and length detention times in the Basin. In order to do this, an extension a minimum of 50 linear feet of storm sewer pipe connected to the existing storm sewer outlet would be constructed and directed to the west end of the Turning Basin. This would help to deflect flow towards the west end of the Basin, rather than short circuiting directly out through the Canal. This would help engage more of the Basin waters and provide more circulation.

- Option B, as described above, includes abandoning the outfall into the Turning Basin. This can be either partial removal of or fill and burying the storm sewer outlet. By directing all inflow through Tributary #1 at the west end of the Basin, more of the Basin area is brought into circulation, reducing the amount of stagnant water and increasing water quality.

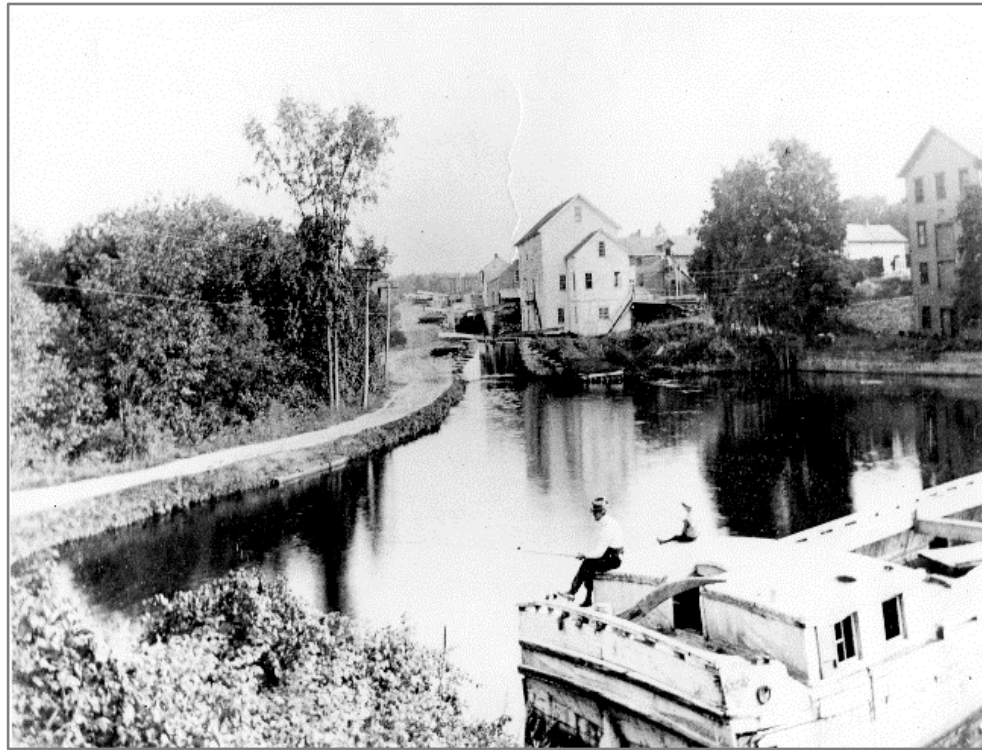
Figure 5 Historical Photo - Looking south at the Turning Basin

Based on observed measurements of width, average depth and velocity, the flow from Tributary #1 into the Turning Basin was estimated to be approximately 2 cubic feet per second (cfs). The watershed area for Tributary #1 is 2 square miles. There is sedimentation throughout the basin and several areas are stagnant due to insufficient mixing of flow. Figures 5 & 6 show photographs of the Turning Basin.

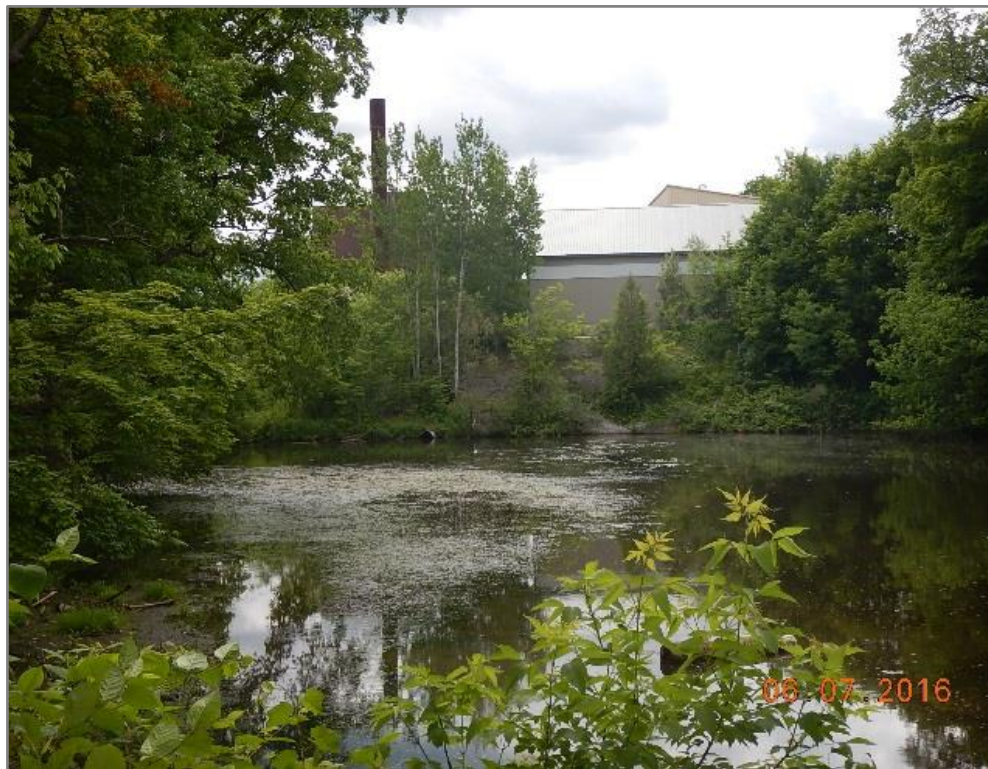
Figure 6 Current Photo - Looking southeast at the Turning Basin

Tributary #1 discharges into the Turning Basin at the northwest end. The Turning Basin is a manmade pond that was formed by blocking the original outlet at the east bank of the Black River Canal. Prior to the canal construction, the tributary into the Turning Basin flowed directly to the Black River. From the High Falls Figure A-17 in Attachment A, it appears that a retaining wall was constructed at the east bank of the Black River Canal. The team was not able to access this area to investigate whether there is evidence of remains of a retaining wall.

The Turning Basin is largely stagnant water. There was little active inflow noted during the site visits. The Turning Basin has also, over time, accumulated sediment along the bottom reducing the basin depth. The combination of standing water with low depths leads to low water quality.

- Installation of a stop-log system underneath the bridge on McAlpine Street that can be used to raise the Turning Basin water surface elevation by 12 inches.

Increasing the depth of the Turning Basin can aid in water quality. Dredging of the Basin would also increase the depth; however, is very costly and would require sediment sampling, permits and continued maintenance whereas the stop-logs are a simple, cost effective feature that can be adjusted and causes little to no impact to the environment.
