Appendix A:

Analysis of the Former Black River Canal

Lyons Falls Brownfield Opportunity Area

Step 3 Implementation Strategy

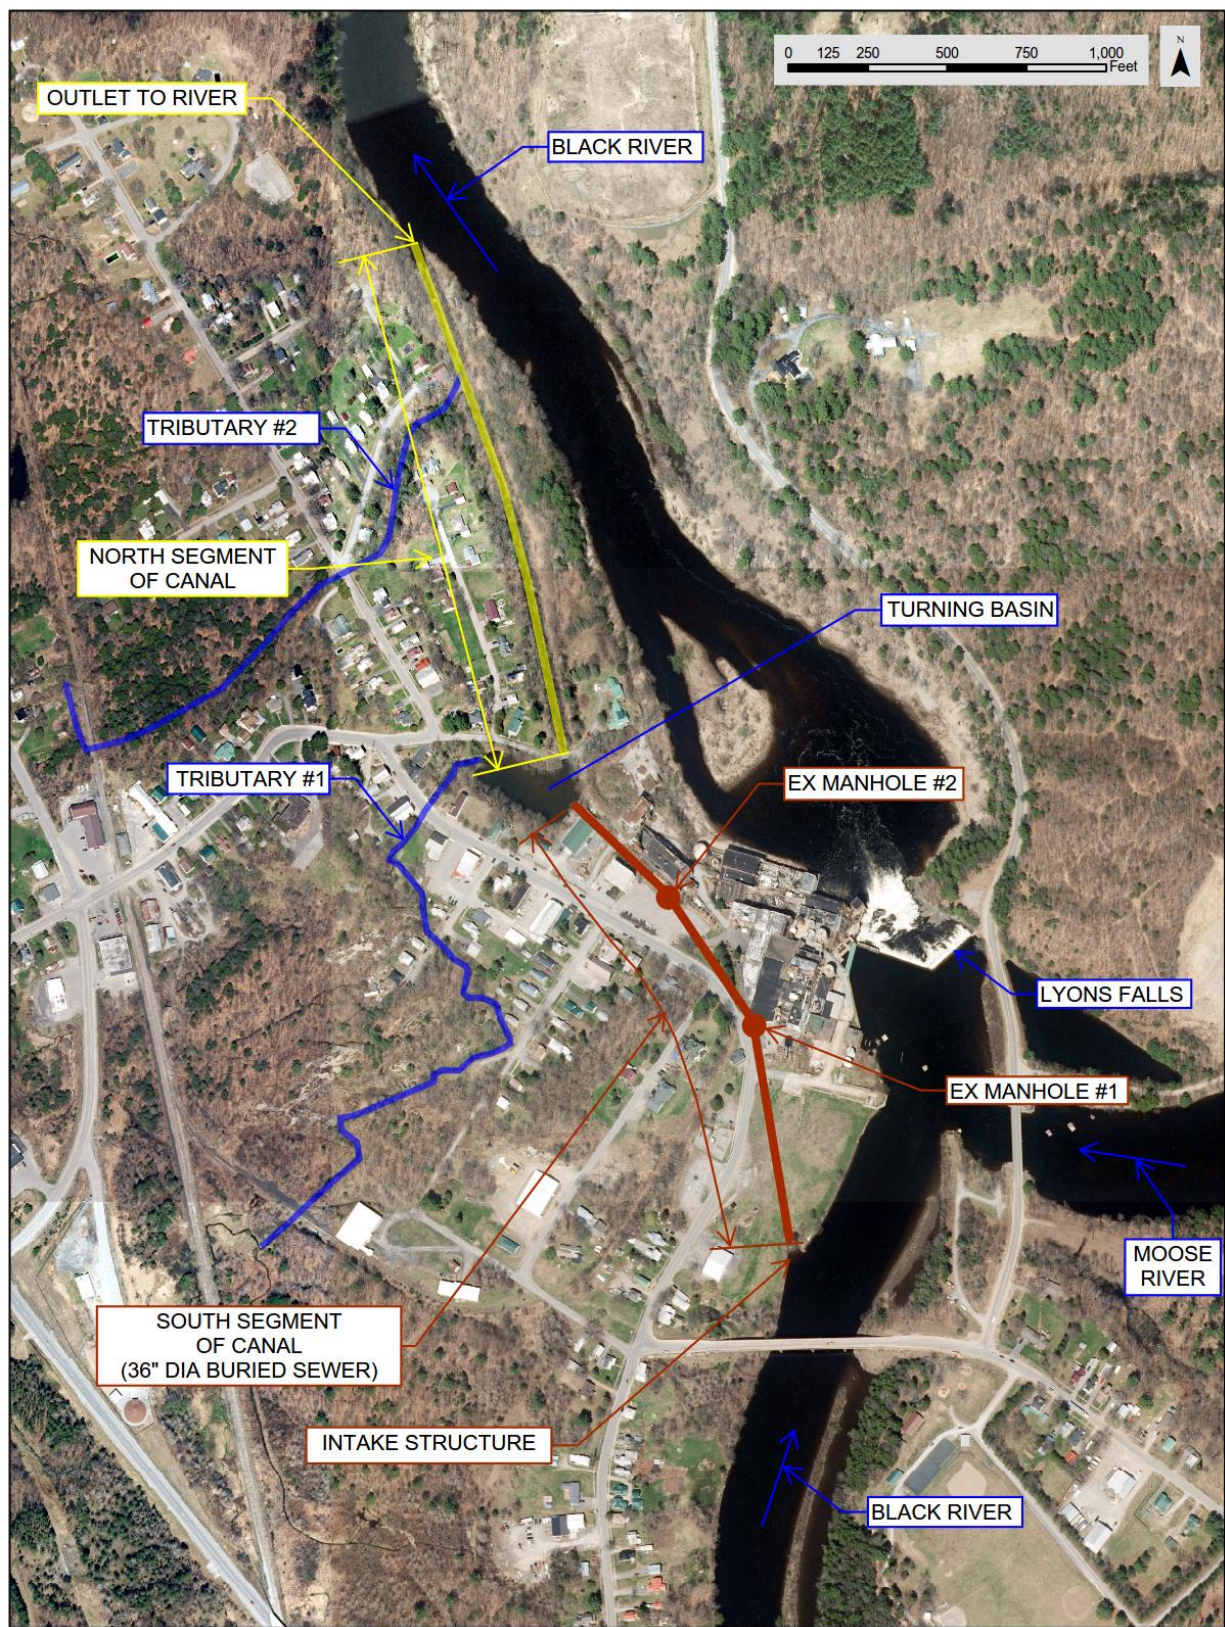
Figure 1 Boundary and Segment Map

Figure 1 illustrates the extent of the analysis boundary. The southern end of the analysis boundary is the inlet from the Black River. The northern end of the boundary is located at the outlet into the Black River. The existing conditions analysis is divided into two segments of the Canal (South and North), illustrated in Figure 1.

- The **South Segment** extends from the canal intake structure on the Black River south of Lyons Falls to the Turning Basin. This section formerly included Locks 103 – 105. Currently, river water is diverted into a 36" buried pipe system leading to the Turning Basin.
- The **North Segment** extends from the Turning Basin to the Black River north of Lyons Falls and includes Locks 106 – 109. This section of the Canal remains largely intact.

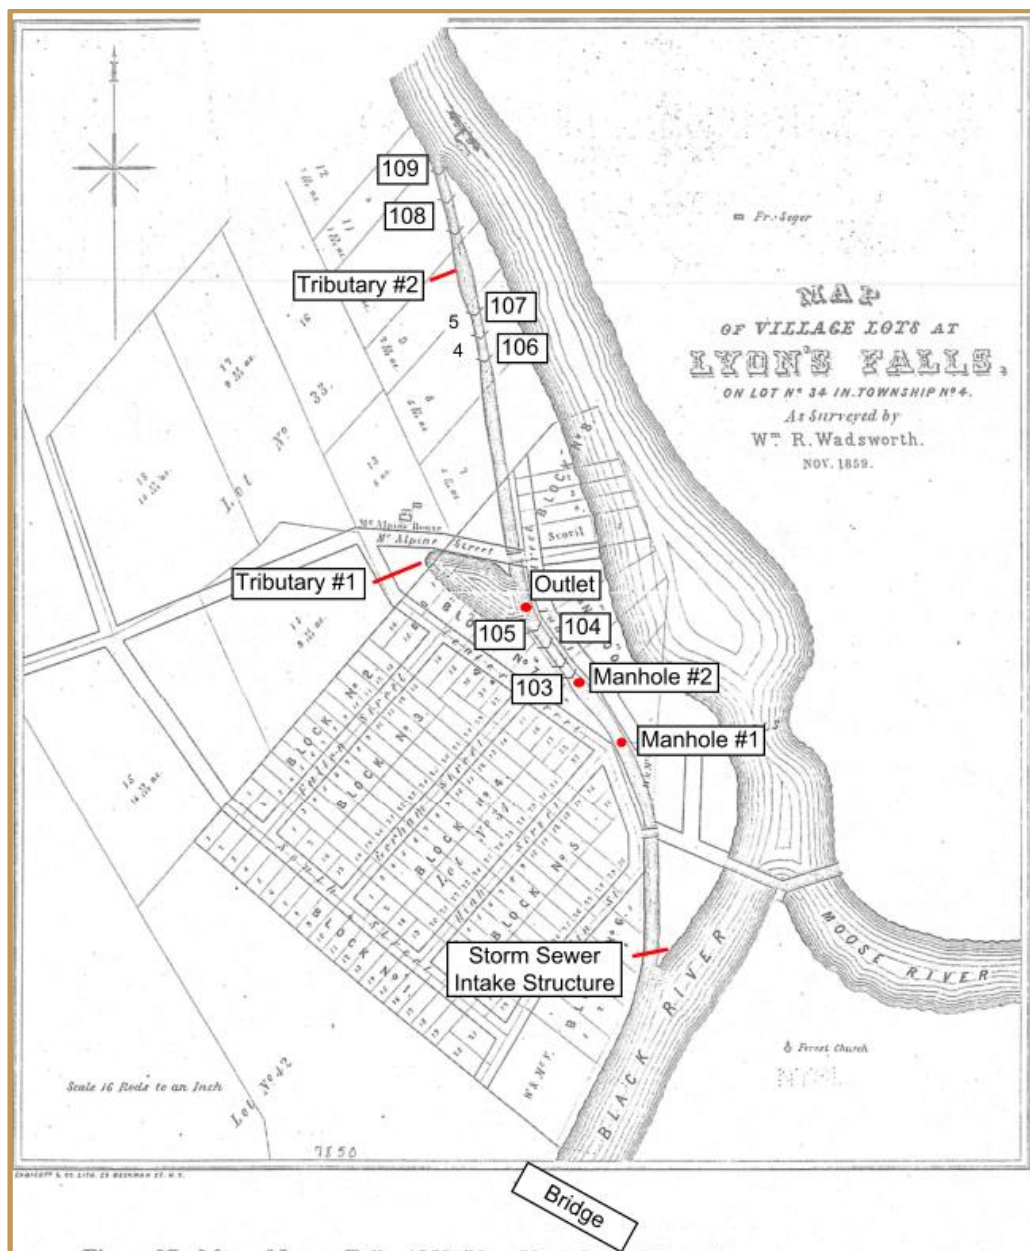
Figure 3 Existing Conditions Features Map

This chapter includes a detailed description of observations of the existing storm sewer, Turning Basin, and canal lock structures. Observations were completed during a site visit conducted on June 7th, 2016. Descriptions of the site visit findings are organized by each segment of the former canal. Photos are included in Attachments B and C. Figure 3 below shows the approximate location of the lock structures, manholes and sewer features located in the field compared to the original canal alignment.
